MELODY LAKE DAM

FRANKLIN COUNTY, MISSOURI

PHASE 1 INSPECTION REPORT NATIONAL DAM SAFETY PROGRAM

PHASE I INSPECTION REPORT
NATIONAL DAM SAFETY PROGRAM

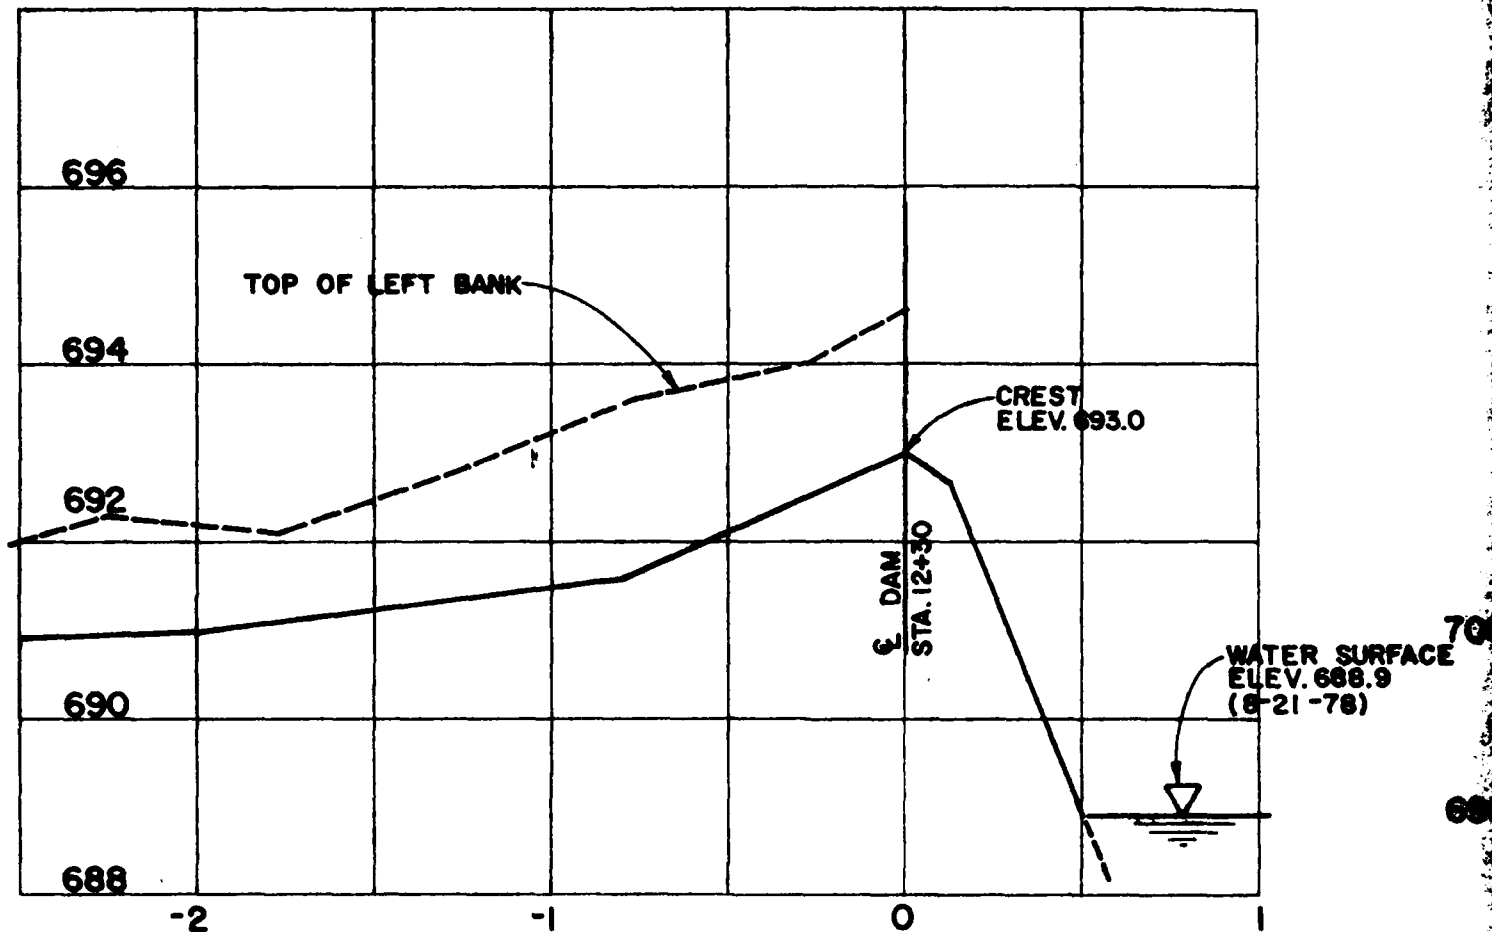
PROFILE EMERGENCY SPILLWAY

The low section in the top of the dam at the right abutment will function as an emergency spillway for lake outflow and it is assumed that it was meant to be that. However, due to terracing of the hillside downstream of the crest (presumably for agricultural purposes), the outlet channel for this spillway is not readily discernible. According to survey data obtained during the inspection, the channel was found to follow the contour of the hillside. Earth from terracing the hill creates a bank on the left (looking downstream)
